1. Introduction

Two batches of GlobalLink 520 contain units that cannot connect to the internet.

GlobalLink520, part number ASS030543020.

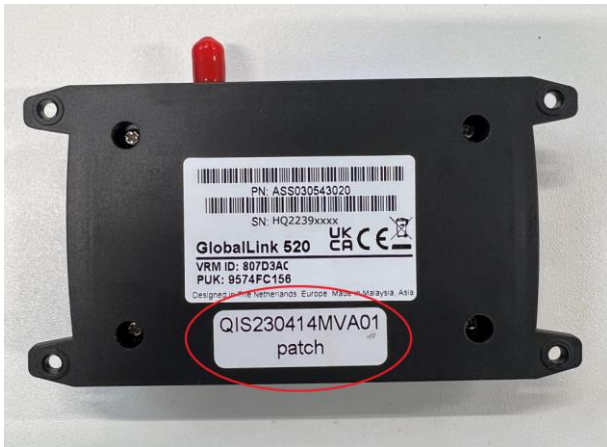
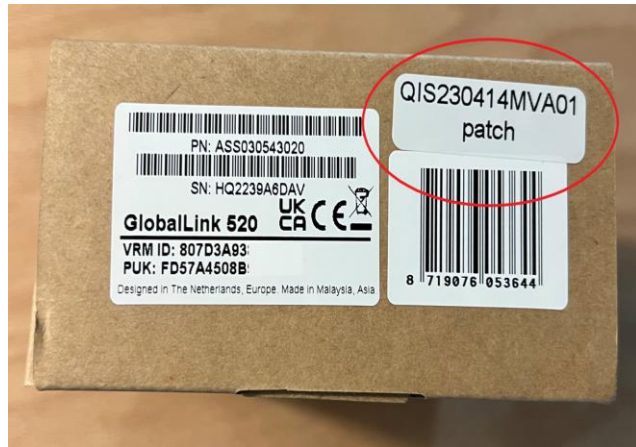
Affected serial numbers: HQ2239 and HQ2242 (*), and then only when firmware version v2.05 is loaded and not reworked in stock. Reworked units are marked with a label containing the text “QIS230414MVA01 patch”, see photos on the next page. Any unit with serialnumber HQ2239 or HQ2242, firmware version v2.05 and containing that label is no longer affected and thus not need to be RMAd.

Labels that mark a fixed unit. Labels are applied both to the unit itself as well as the carton:
