# Change Logs Galvo / Symo / Primo / Eco

## Fronius Galvo

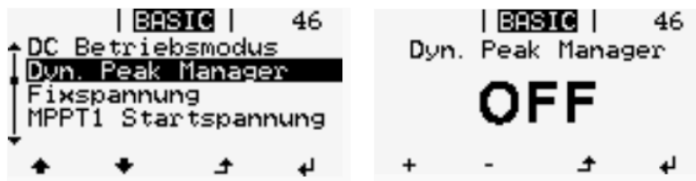
Bei Fronius Symo 10.0-3 M - 20.0-3 M ist der Dynamic Peak Manager bei allen Länder-Setups implementiert und auswählbar.

**WICHTIG!** Um den Dynamic Peak Manager nachträglich zu aktivieren, muss nach dem Update das Länder Setup neu ausgewählt werden und der Modus im Service Menu Basic von „OFF“ auf „ON“ gestellt werden.

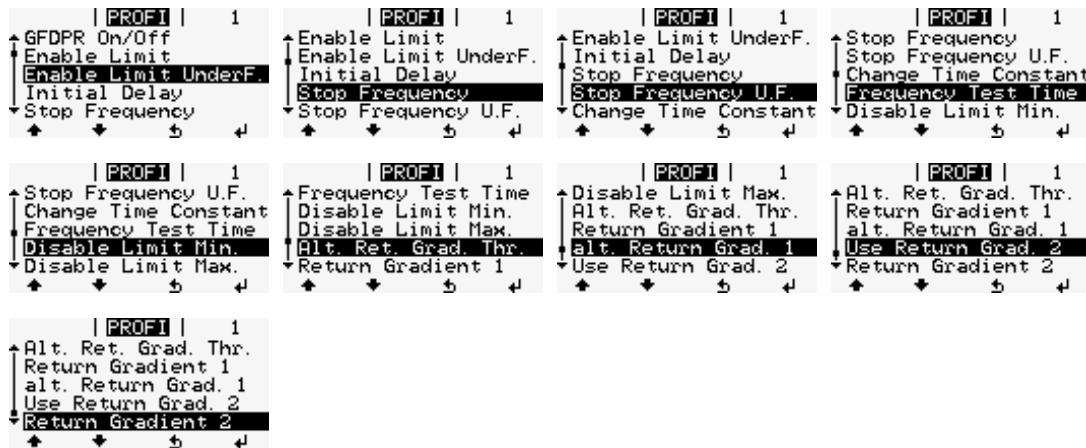
/ Extension of the P (f) settings for the GDPR function by the following parameters:

- / Start frequency at underfrequency
- / Stop frequency at overfrequency
- / Stop frequency at underfrequency
- / Frequency Test Time (Duration of frequency monitoring before return to nominal power)
- / Disable Limit min (lower limit for frequency monitoring)
- / Alternative Return Gradient Threshold (Percentage drop of nominal power, from which "Alternative Return Gradient 1" is activated)
- / Alternative Return Gradient 1 (Alternative return gradient to maximum power in %/s, based on the difference between frozen and lowest power)
- / Use Return Gradient 2 Mode (Mode: 0 ... 'Return Gradient 1' or 'Return Gradient 1 Alternative' is used, 1 ... 'Return Gradient 2' is used)
- / Return Gradient 2 (Further return gradient to the maximum power in %/s, based on nominal power, if this is activated)

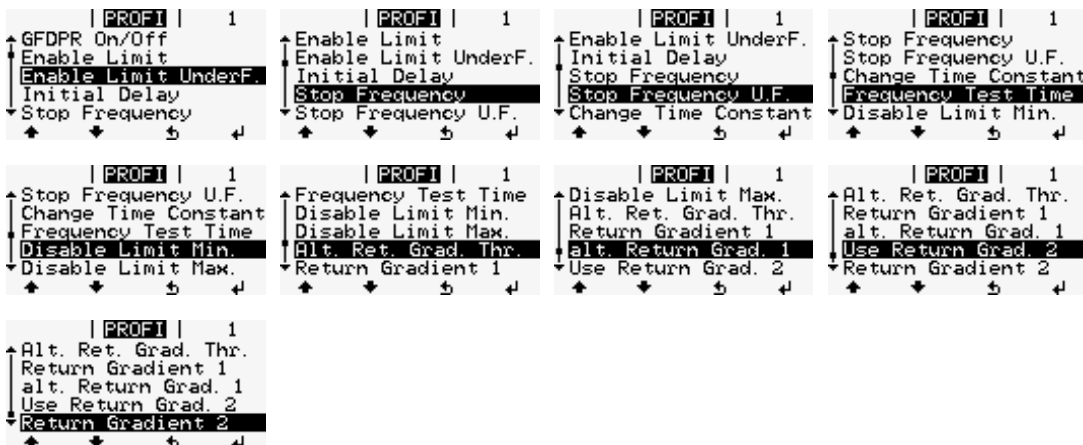
- / Extension of the P (f) settings for the GDPR function by the following parameters:

- / Start frequency at underfrequency
- / Stop frequency at overfrequency
- / Stop frequency at underfrequency
- / Frequency Test Time (Duration of frequency monitoring before return to nominal power)
- / Disable Limit min (lower limit for frequency monitoring)
- / Alternative Return Gradient Threshold (Percentage drop of nominal power, from which "Alternative Return Gradient 1" is activated)
- / Alternative Return Gradient 1 (Alternative return gradient to maximum power in %/s, based on the difference between frozen and lowest power)
- / Use Return Gradient 2 Mode (Mode: 0 ... 'Return Gradient 1' or 'Return Gradient 1 Alternative' is used, 'Return Gradient 2' is used)
- / Return Gradient 2 (Further return gradient to the maximum power in %/s, based on nominal power, if this is activated)

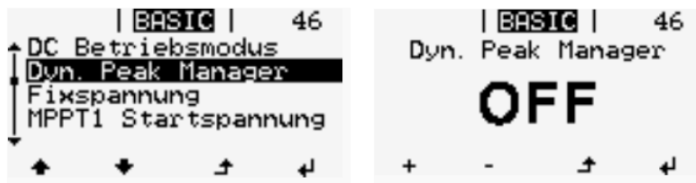
At the inverters Fronius Symo 3.0-3 M - 8.2-3 M the Dynamic Peak Manager is implemented and selectable in all country setups .

**IMPORTANT!** To activate the Dynamic Peak Manager subsequently, after the update the country setup must be re-selected and the mode in the Basic service menu must be set from "OFF" to "ON".
